RE: 13 Depot Street, Windham, Maine
Jacques Whitford Project No. mep04127

**PHASE I AND II
ENVIRONMENTAL SITE ASSESSMENTS
Former Depot Energy Company
13 Depot Street, Windham, Maine**

Jacques Whitford Project No. MEP04127

June 17, 2004

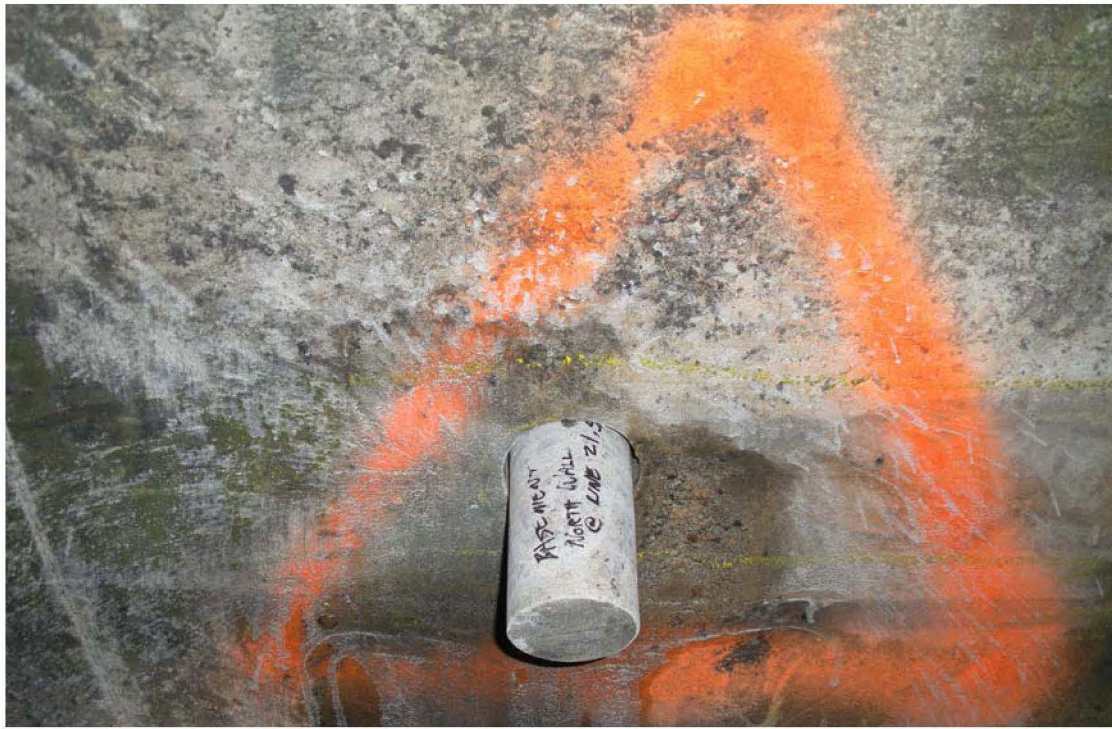
PHOTO
#3.3
sc 002.jpg

North Wall Core: Core taken from north wall for material evaluation.

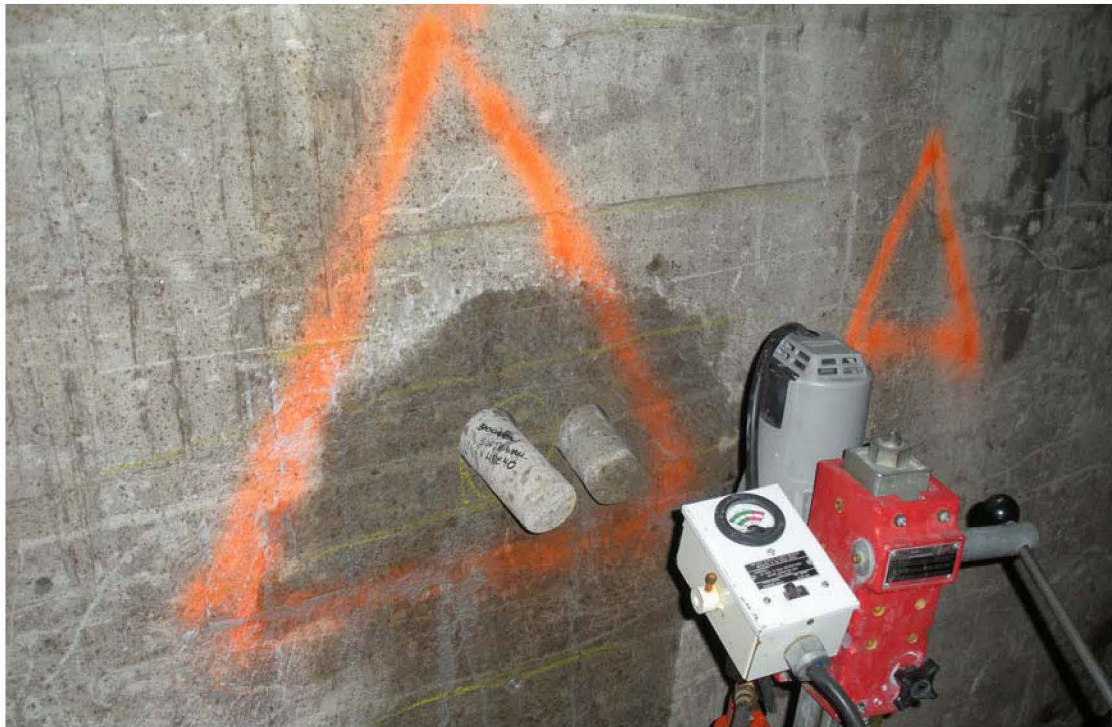
PHOTO
#3.4
sc 004.jpg

South Wall, Core at Line 40: Core taken at Line 40 for materials evaluation.

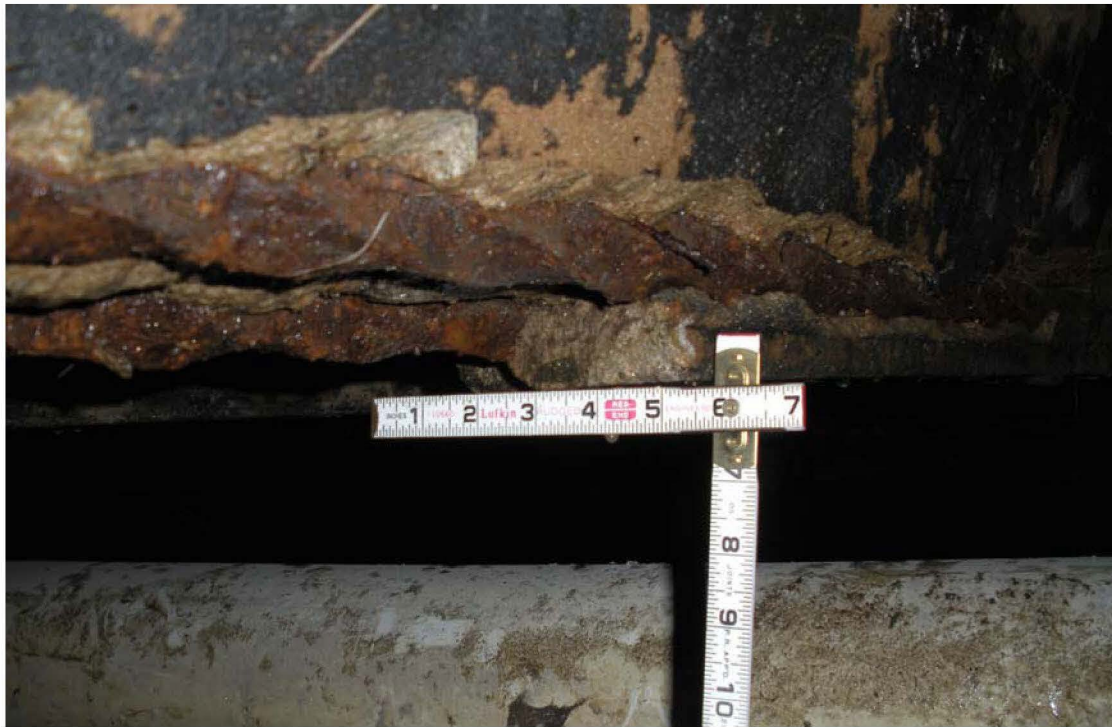
PHOTO
#3.5
1019 026.jpg

West side Building Concrete Beam below slab: Note spalled concrete and exposed steel rebar. Concrete repairs will be significant under this slab.

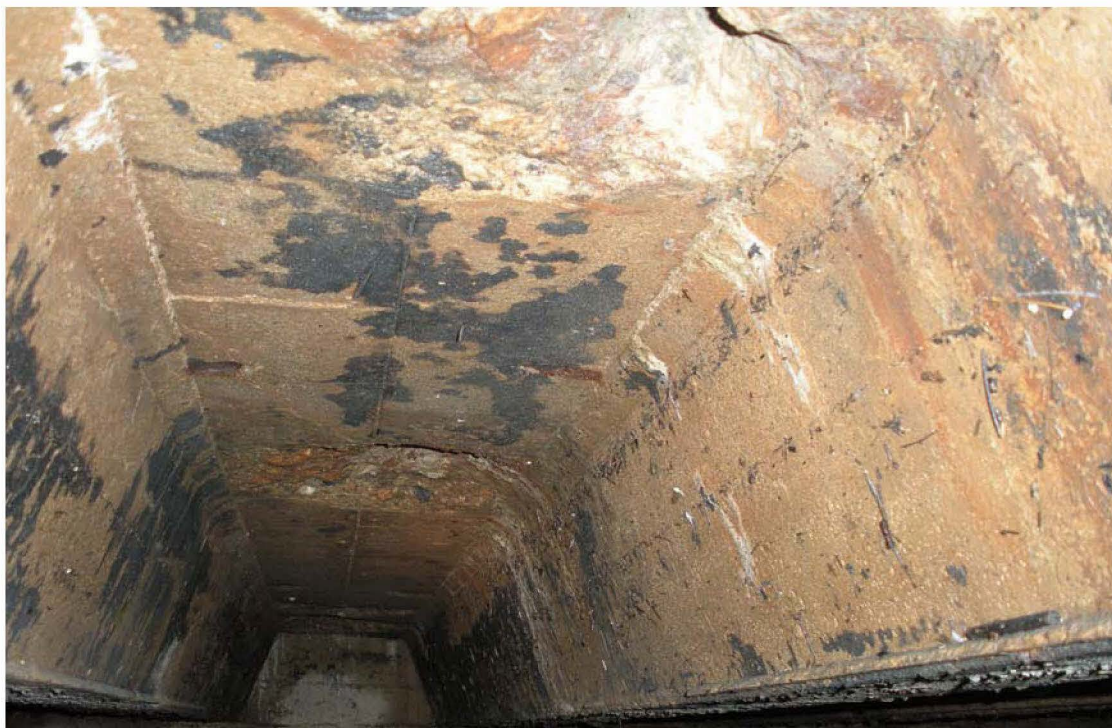
PHOTO
#3.6
1019 014.jpg

Underside of slab near Grid Line 43 and Grid Line B. Though not visible, small cracks exist along the length of many of the interior beams.

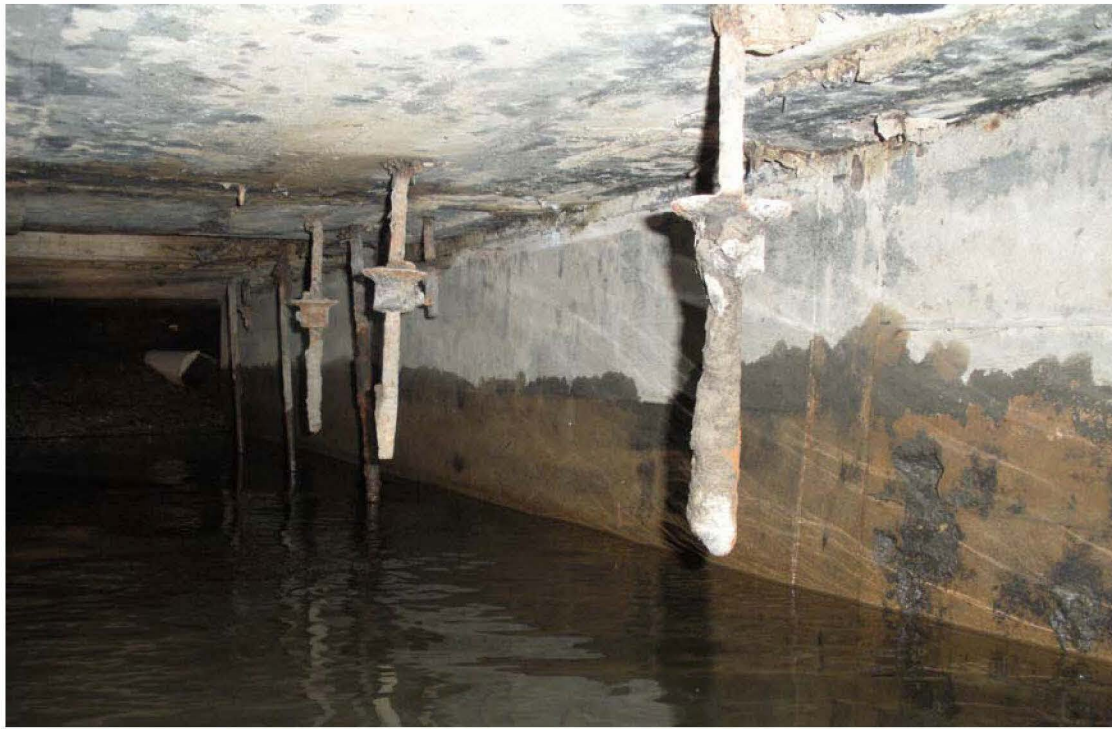
PHOTO
#3.7
923 045.jpg

B-Line Grade Beam, Looking East toward Line 40: Anchors that supported slab formwork are visible; Grade Beam visible at right.

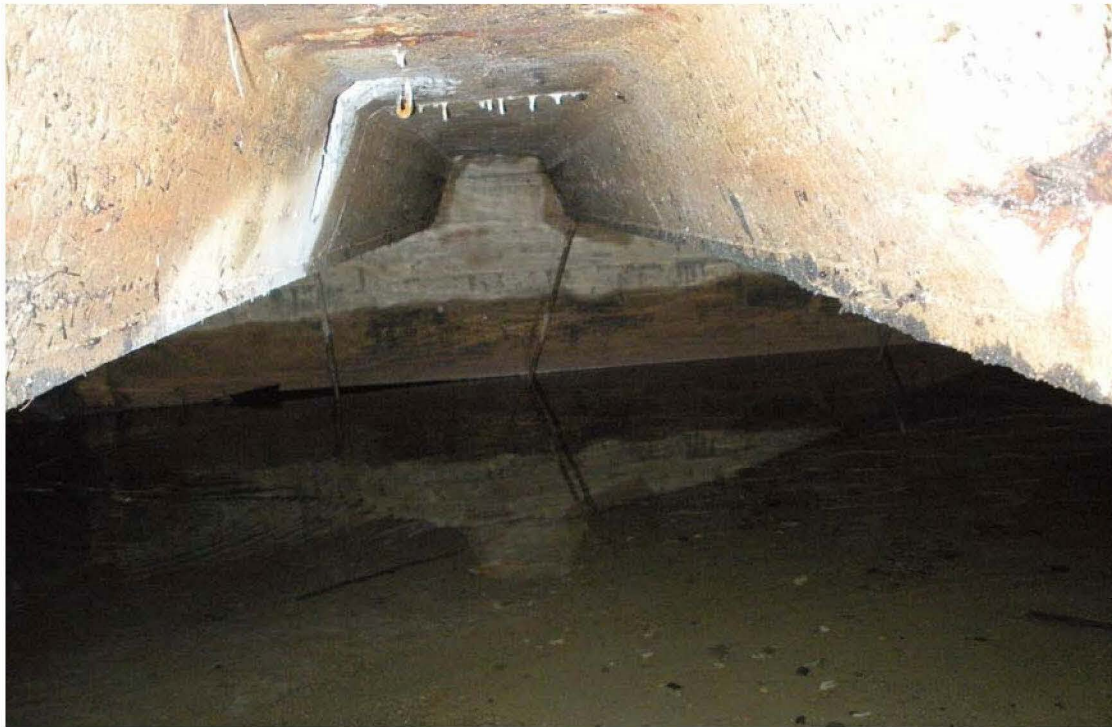
PHOTO
#3.8
923 010.jpg

West End, Looking from Line D to Line C near Column Line 43: Note Shallower water depth, this area.
